Problem: Replace the rubber in the sway bar support bracket.

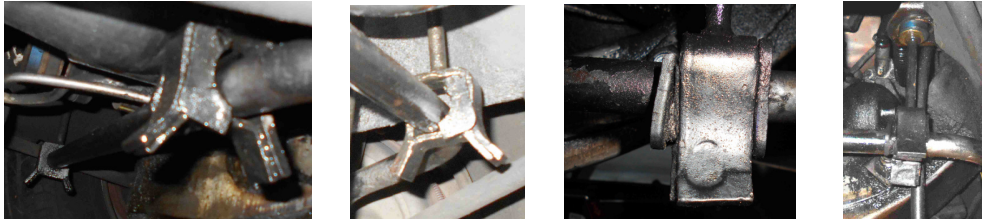
The rubber had deteriorated, perhaps because of a leaky power steering pump:

Notice the large spot weld on the third & fourth pictures. The normal procedure is to drill out the two welds and replace them with bolts after replacing the rubber block. In this case that would have required such a large drill as to leave little metal behind, so we used a reciprocating saw to make two cuts to remove the middle of bottom plate to allow removal of the hanger. Right picture is the hanger after grinding off the leftover pieces of the bottom plate with an angle grinder:
